Vehicle Component Characterization

Vol. I: Project Results

David J. Segal
Leonard R. Kamholz
Davis G. Griffith

January 1987
Final Report

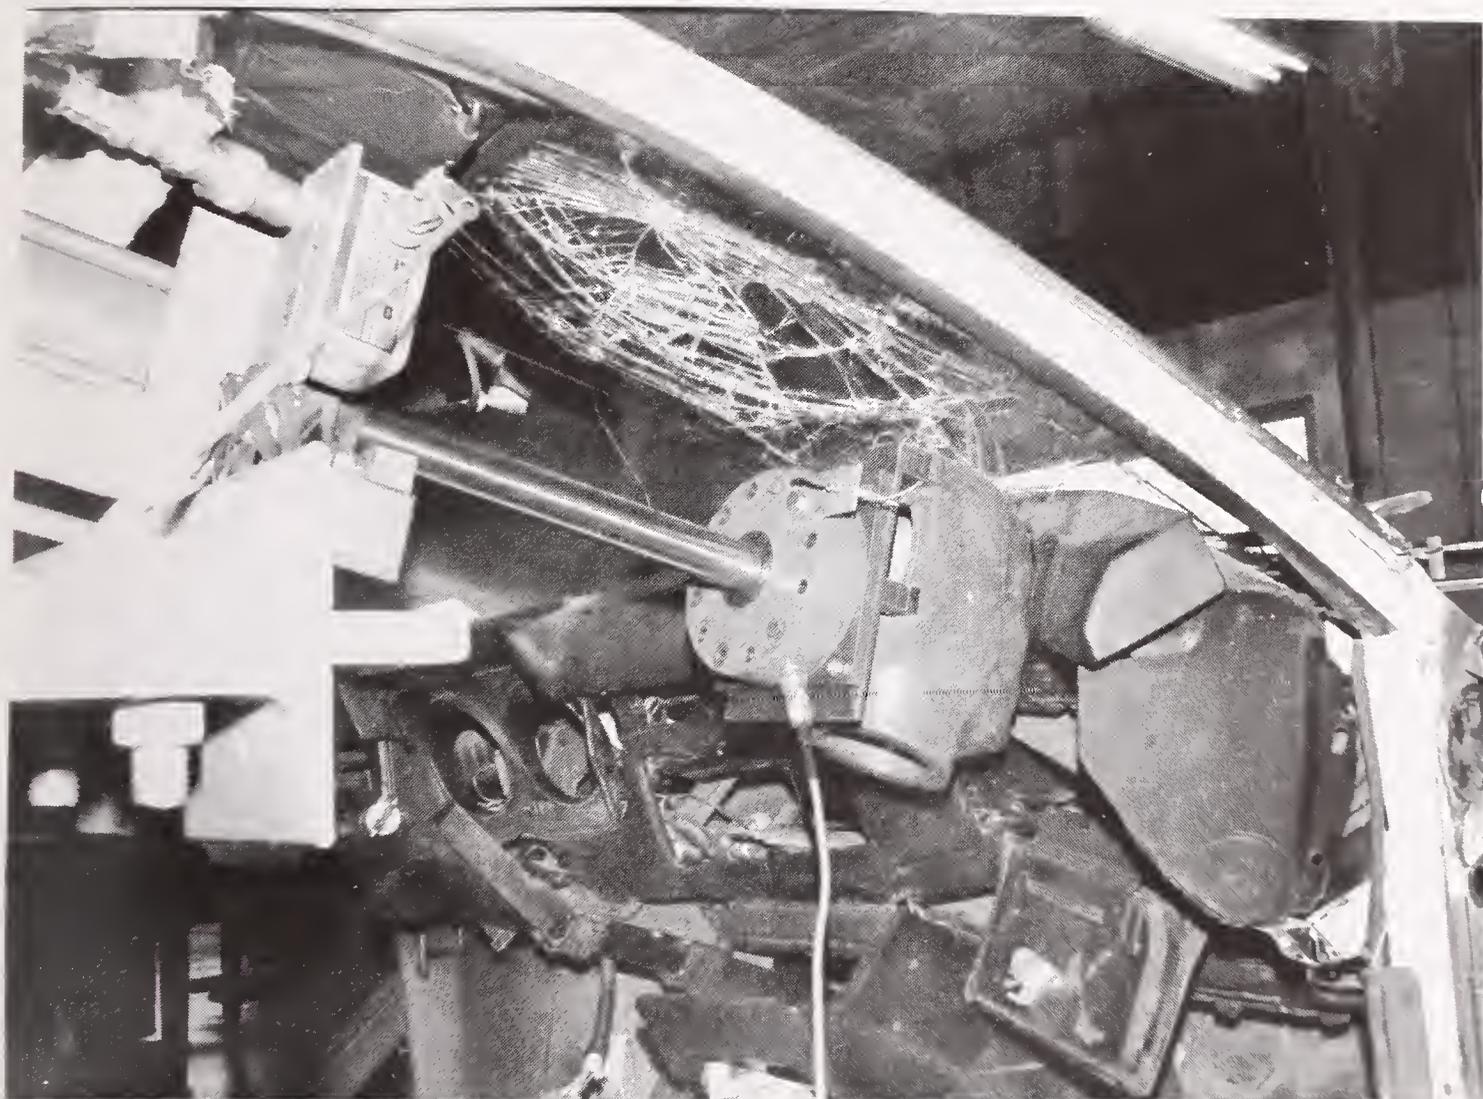
FIGURE 3-7. PASSENGER HEAD SET-UP

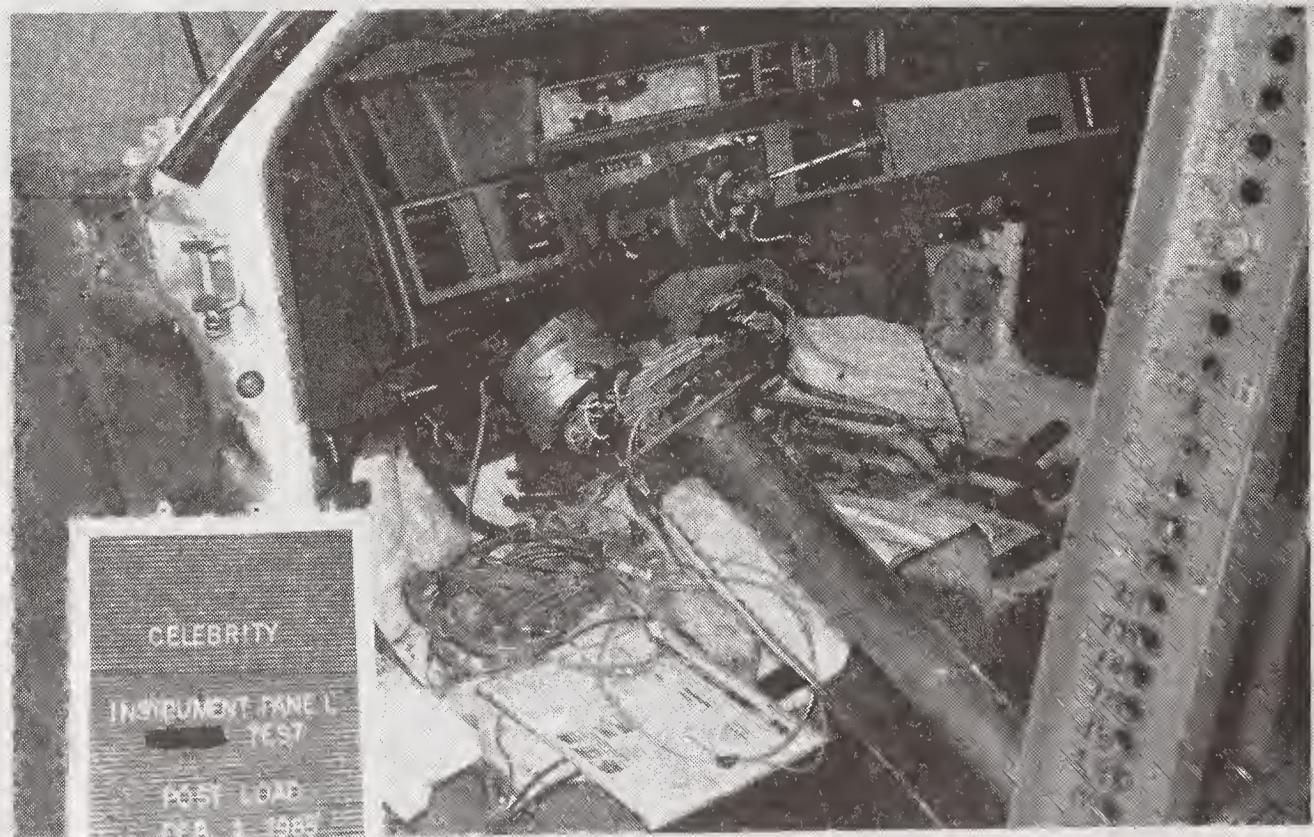
FIGURE 3-12. DYNAMIC DRIVER'S FEMUR

The instrumentation used during dynamic instrument panel testing consisted of acceleration sensors, a time-of-contact switch (time zero), a velocity sensor, an electrical firing system, and signal conditioning. All signals were recorded on a Hewlett Packard Instrumentation Tape Recorder. The tape recorder was set up to record time traces of acceleration, contact time, and velocity before impact. The accelerometers were mounted on the impactor shaft as close to its centerline as possible. Impact velocity was measured using a laser-wand which produced digital readout of elapsed time for the wand to pass through the beam and a signal to be recorded on the tape recorder. The time zero switch was placed on the instrument panel so that the body form would contact it first. Once the instrumentation was setup, photos and measurements were taken to document the position of the major components prior to impact. The setup distance was verified, maximum penetration assembly was measured and the target location verified. The targets for all dynamic testing were identical to the static instrument panel testing for each respective body form (see Figures 3-11, 3-12, and 3-13).

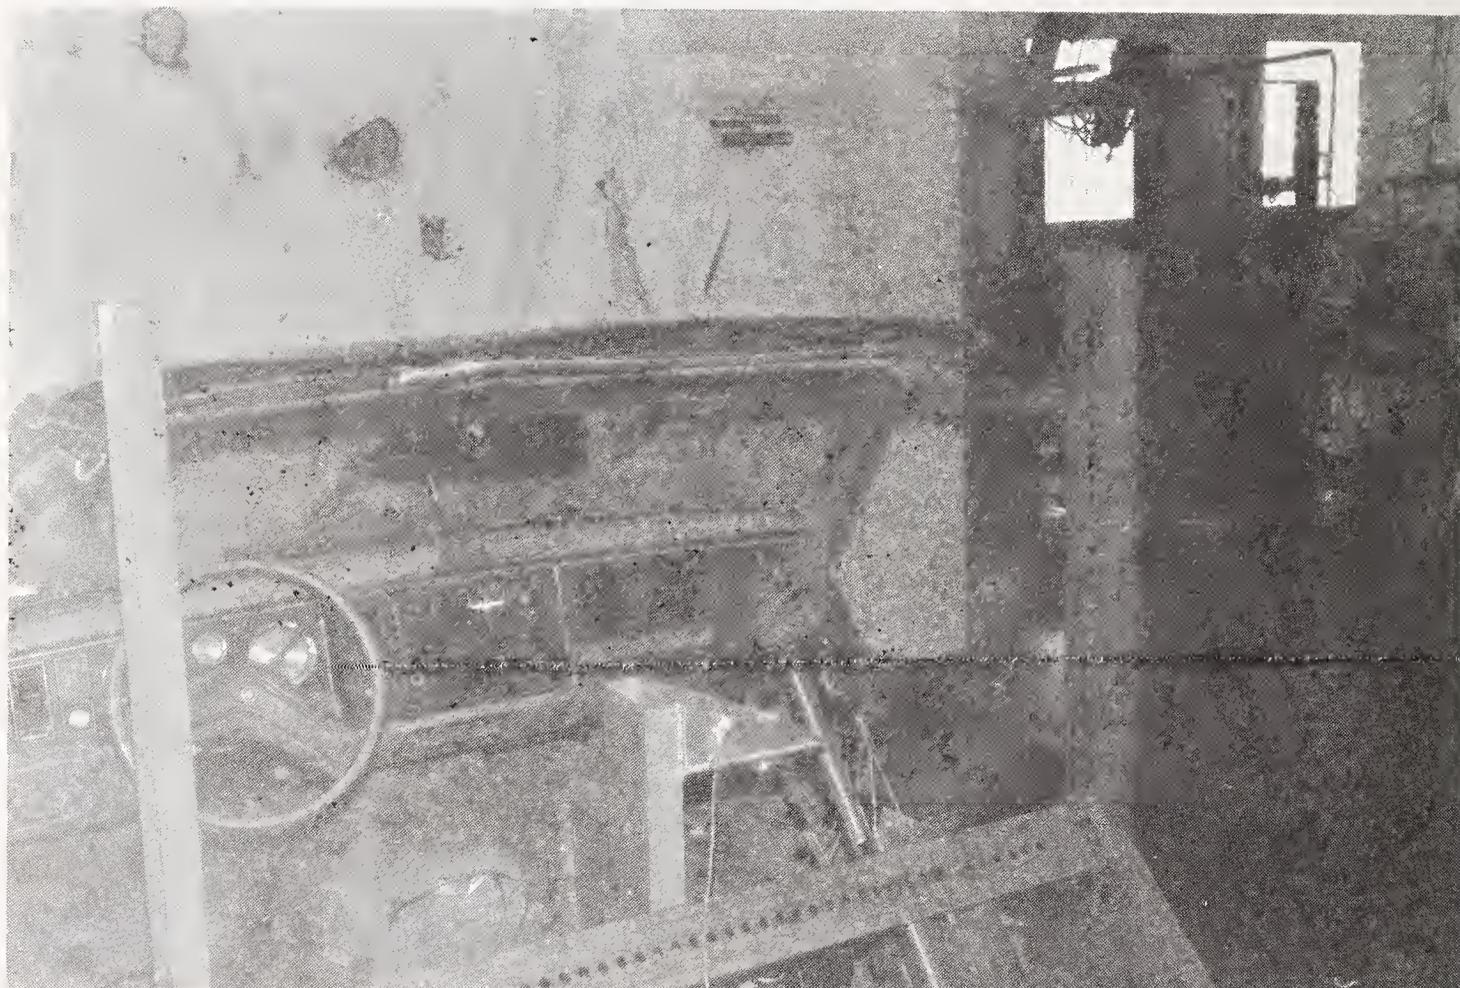
FIGURE 3-16. WINDSHIELD TEST LOAD FRAME

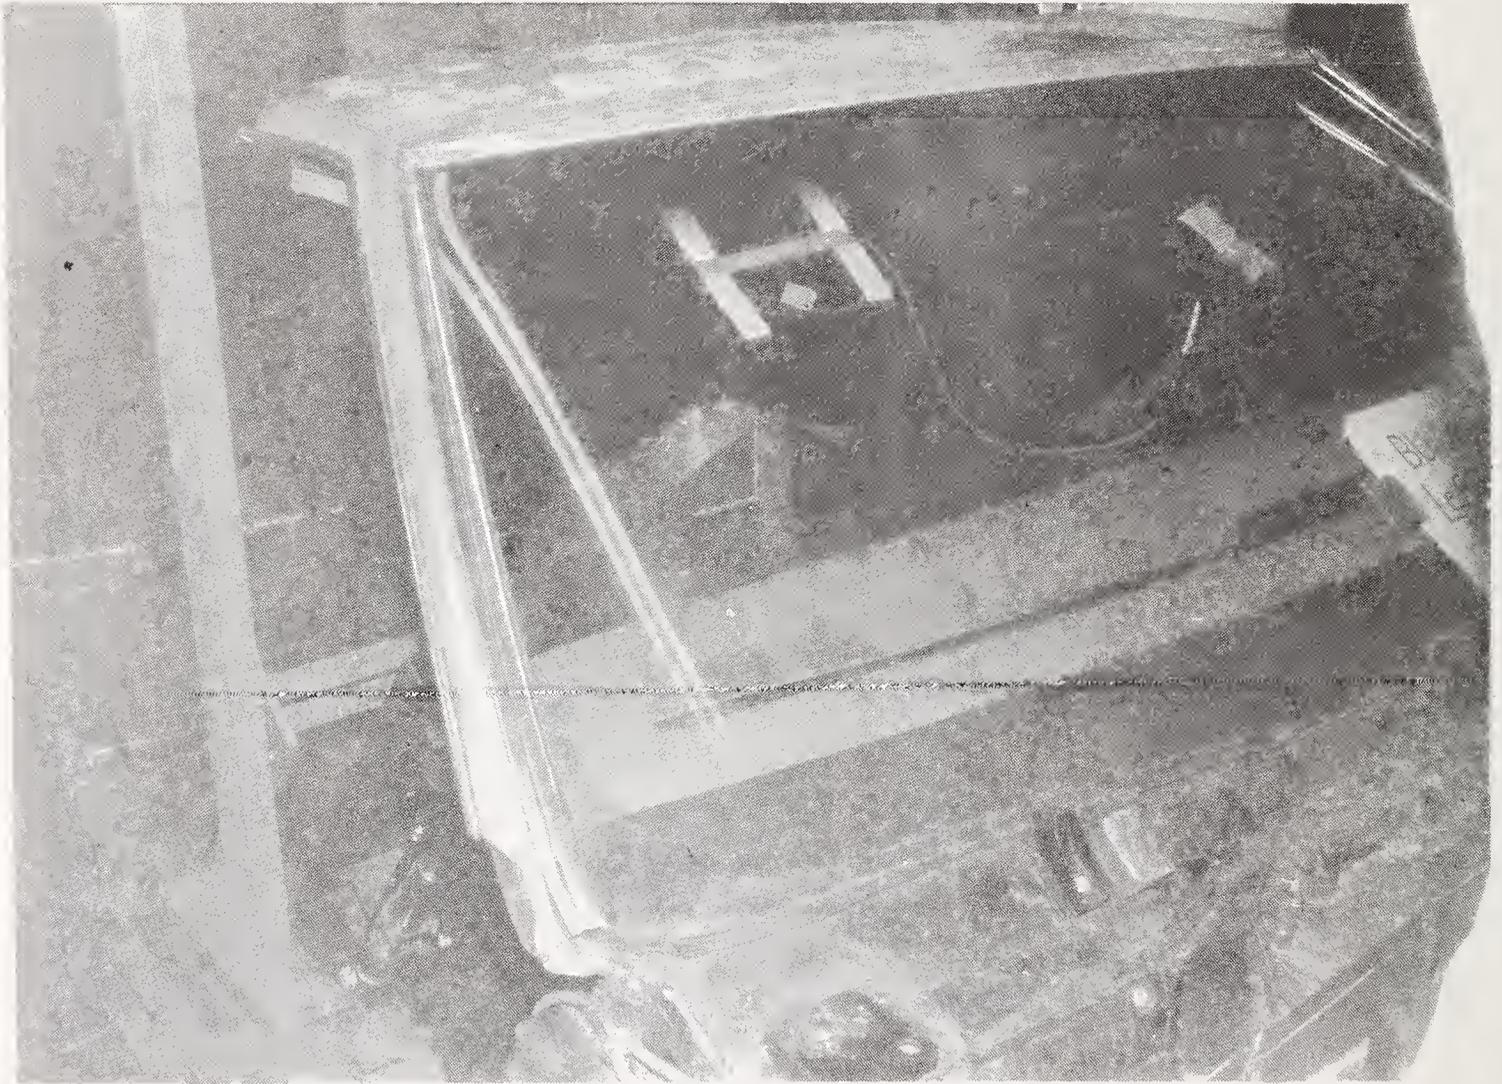
FIGURE 3-18. STANDARD WINDSHIELD TARGET

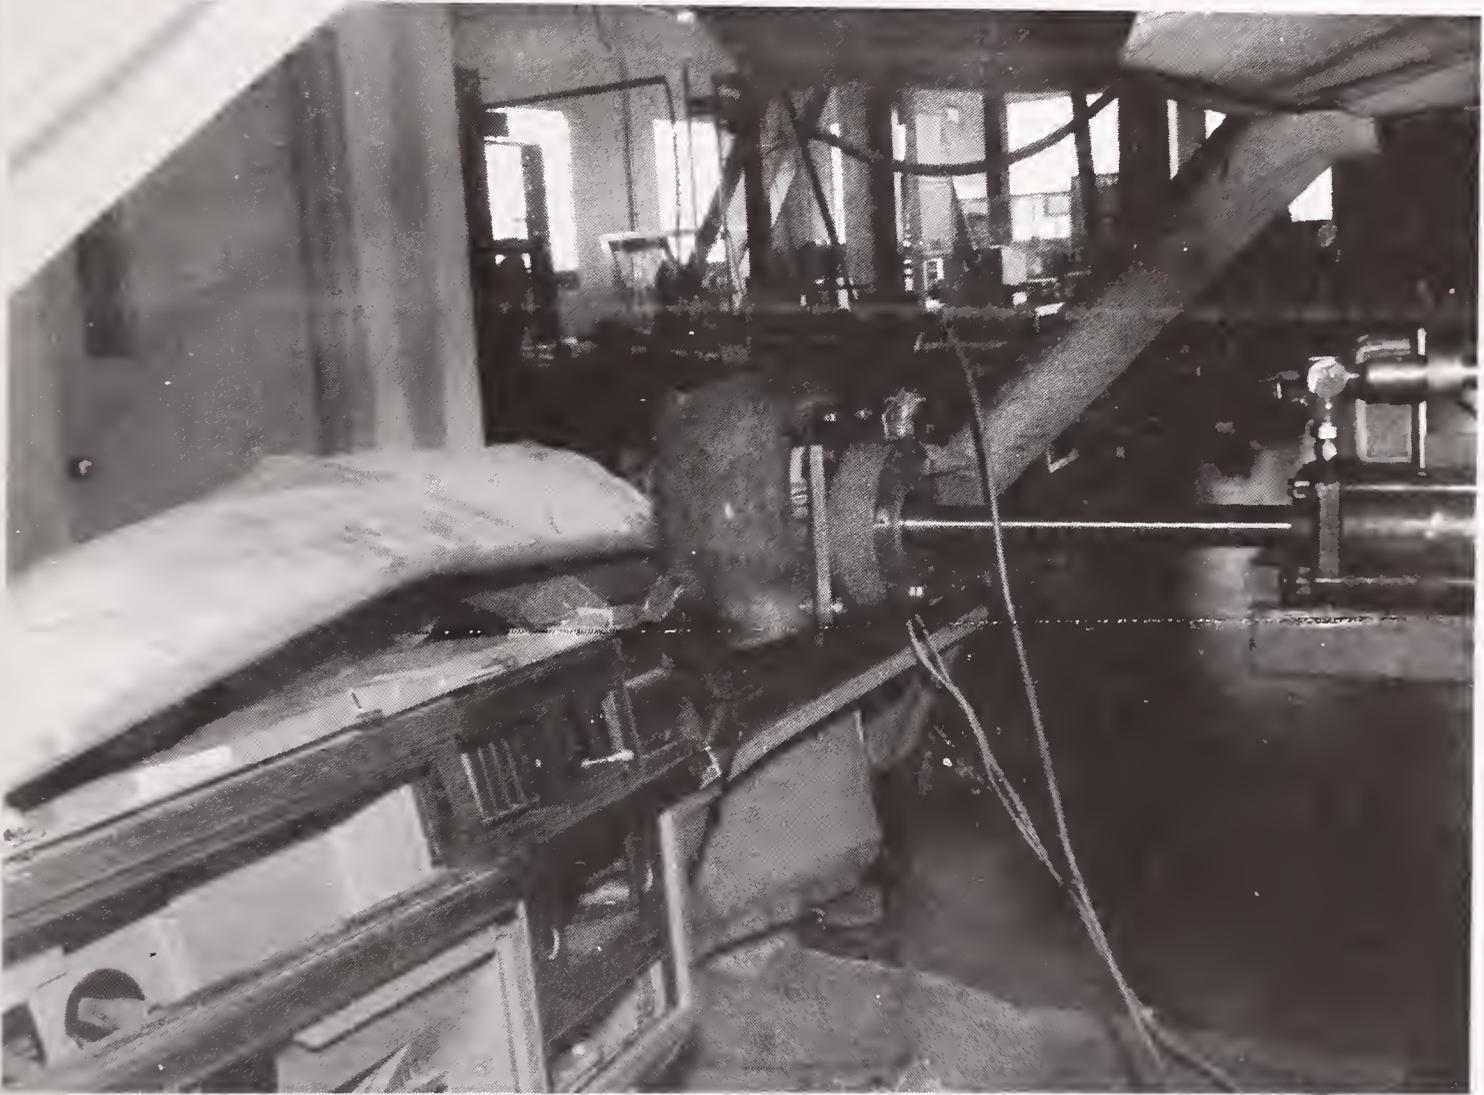
FIGURE 3-21. HEAD PARAMETRIC TEST TYPE 2

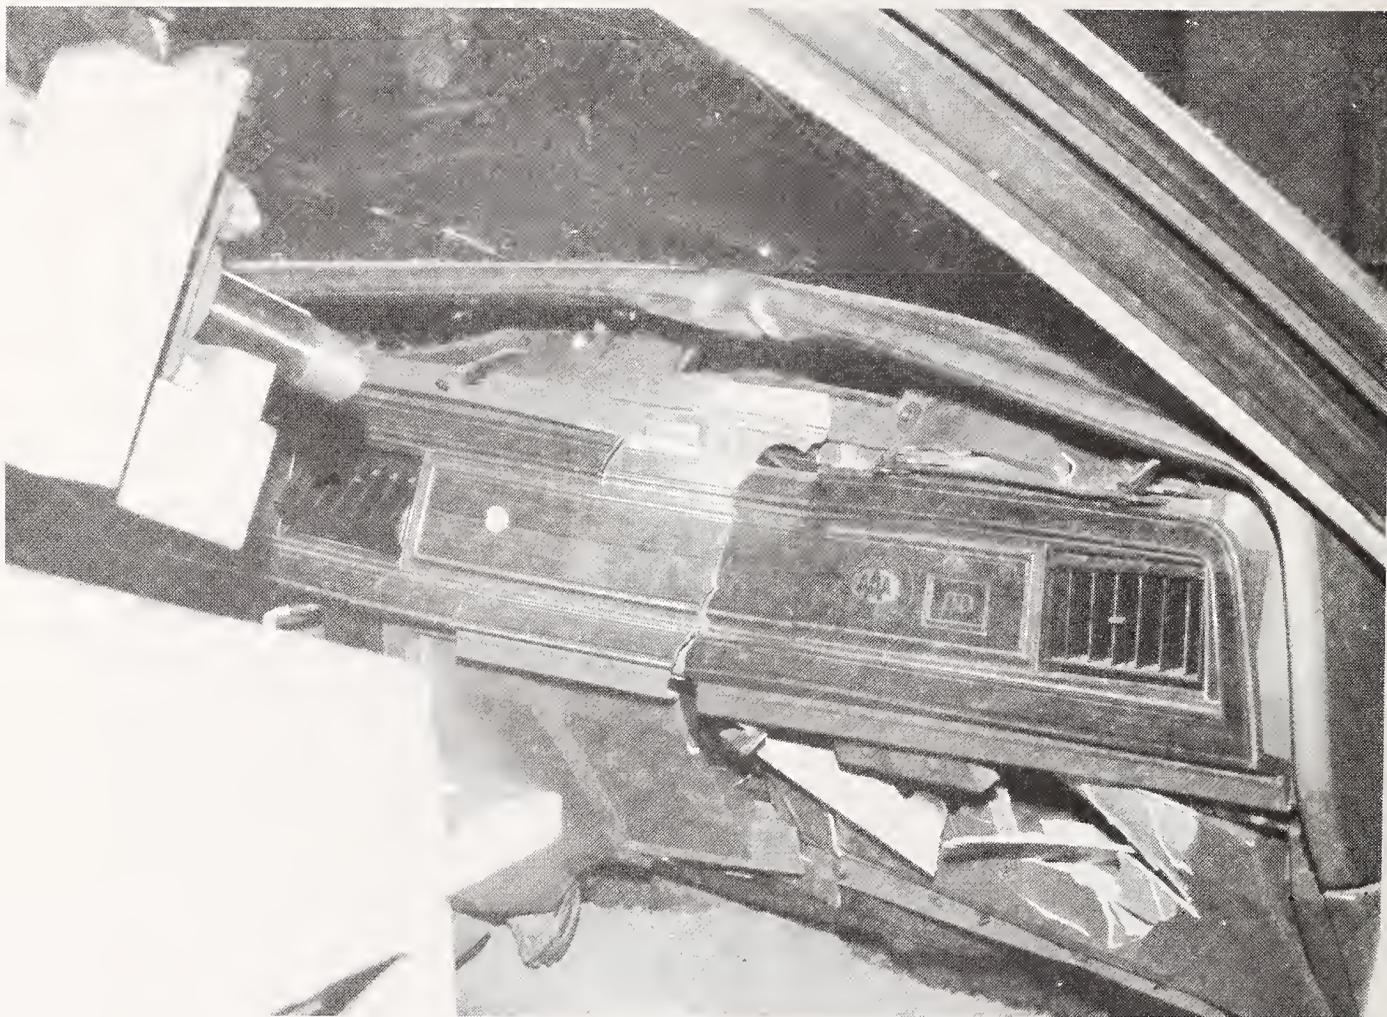
FIGURE 4-9. PLASTIC INSTRUMENT PANEL (LTD)

Noted on the data sheets in Appendix A are the material that the instrument panel was made of. The instrument panel construction could be categorized primarily into categories of: all metal, all plastic (or synthetic material), or a combination of both. Shown in Figure 4-9 is a photo of the LTD instrument panel which is primarily of hard plastic. The photo was the post test condition and illustrates the brittle nature of failure. In contrast, Figure 4-10 shows the Pinto instrument panel which is made of metal. The photo shows the instrument panel bends rather than fractures. However, there are still items that break, such as the hinge on the glove box door. The instrument panels that were part metal and part plastic usually consisted of a plastic dash with a metal top, such that of the Omni. Shown in Figure 4-11 is a post test picture of the Omni that illustrates the metal top panel and the soft plastic front panel. The soft plastics of the Omni contrasts with the hard plastic of the LTD in that it doesn't fail in a brittle manner. In comparing the force-deflection plots in Figure 4-12 the LTD shows a more irregular force plot due to cracking of the dash compared to the Pinto.

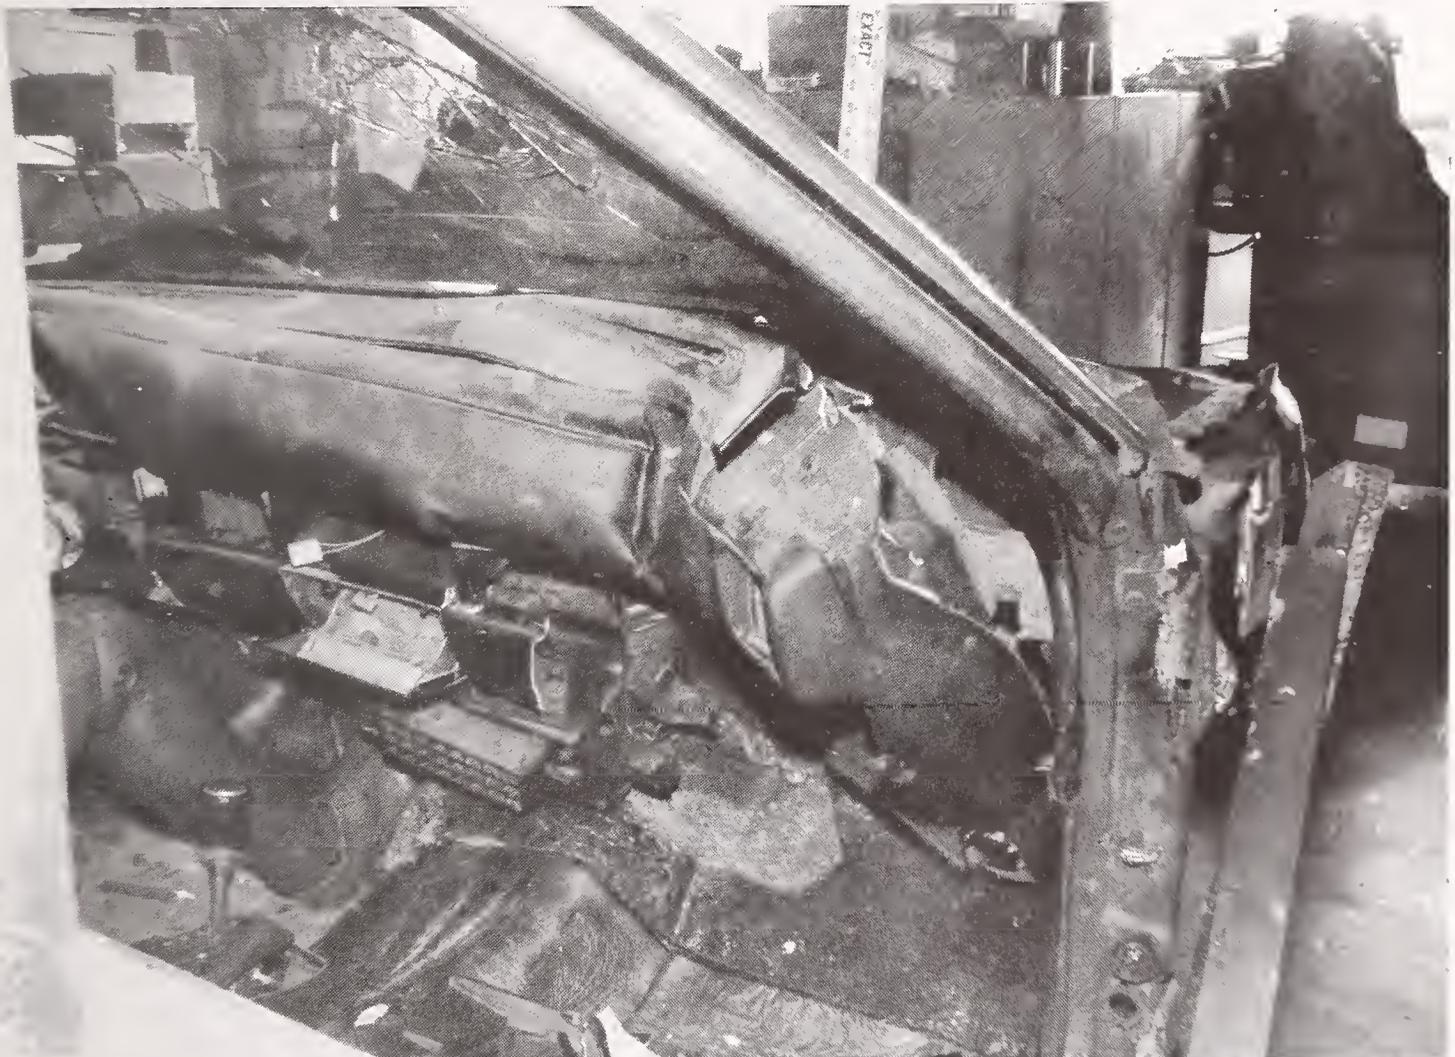
FIGURE 4-11. COMBINED PLASTIC AND METAL INSTRUMENT PANEL (OMNI)

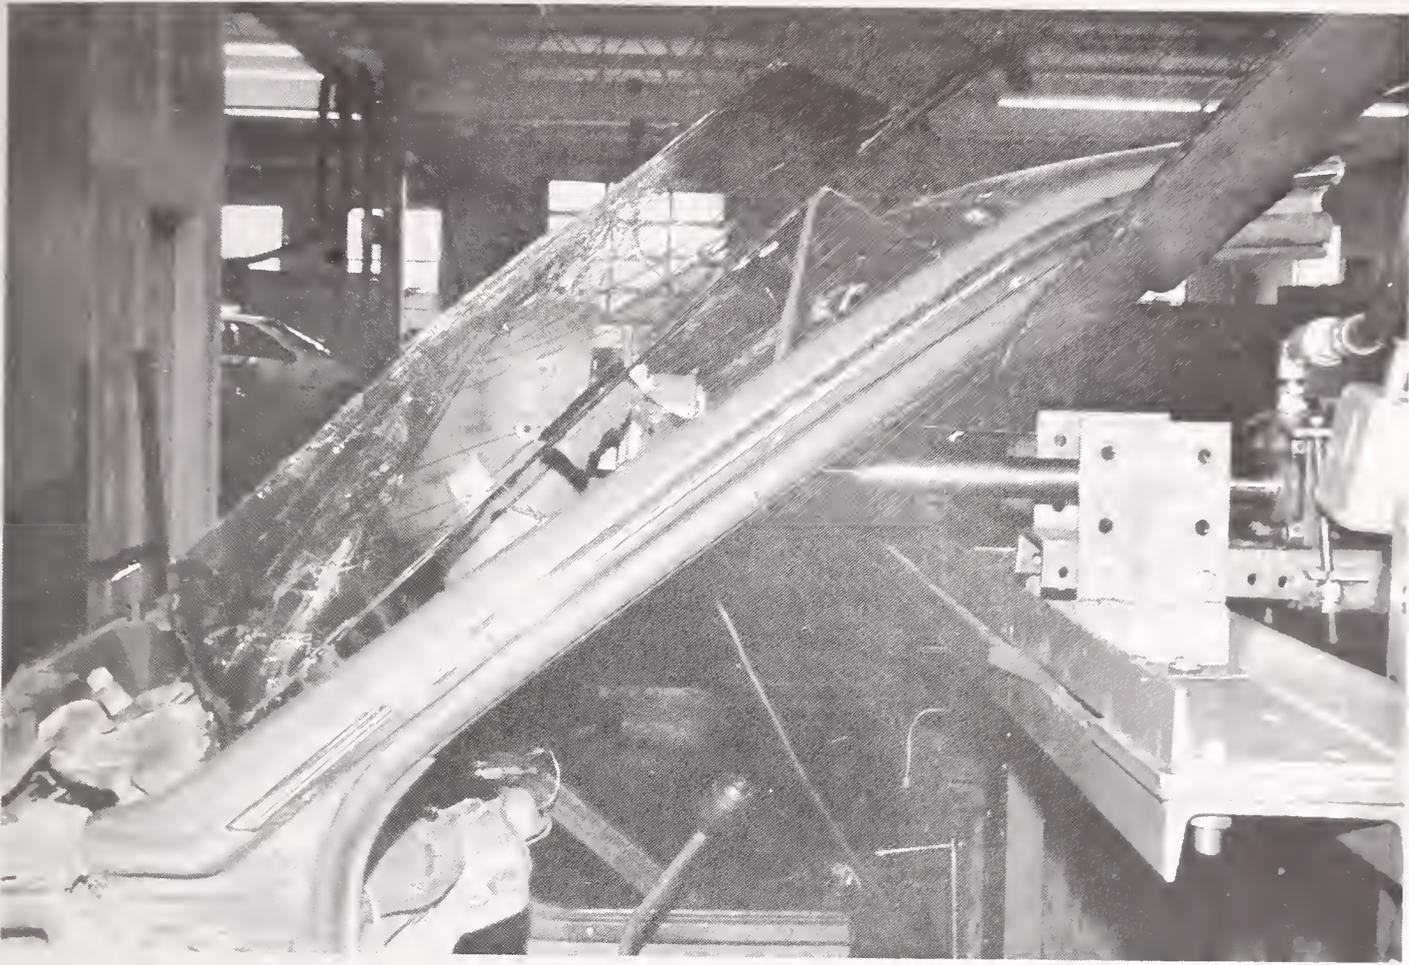
FIGURE 4-24B. TYPICAL STATIC WINDSHIELD TEST (EXTERIOR VIEW)

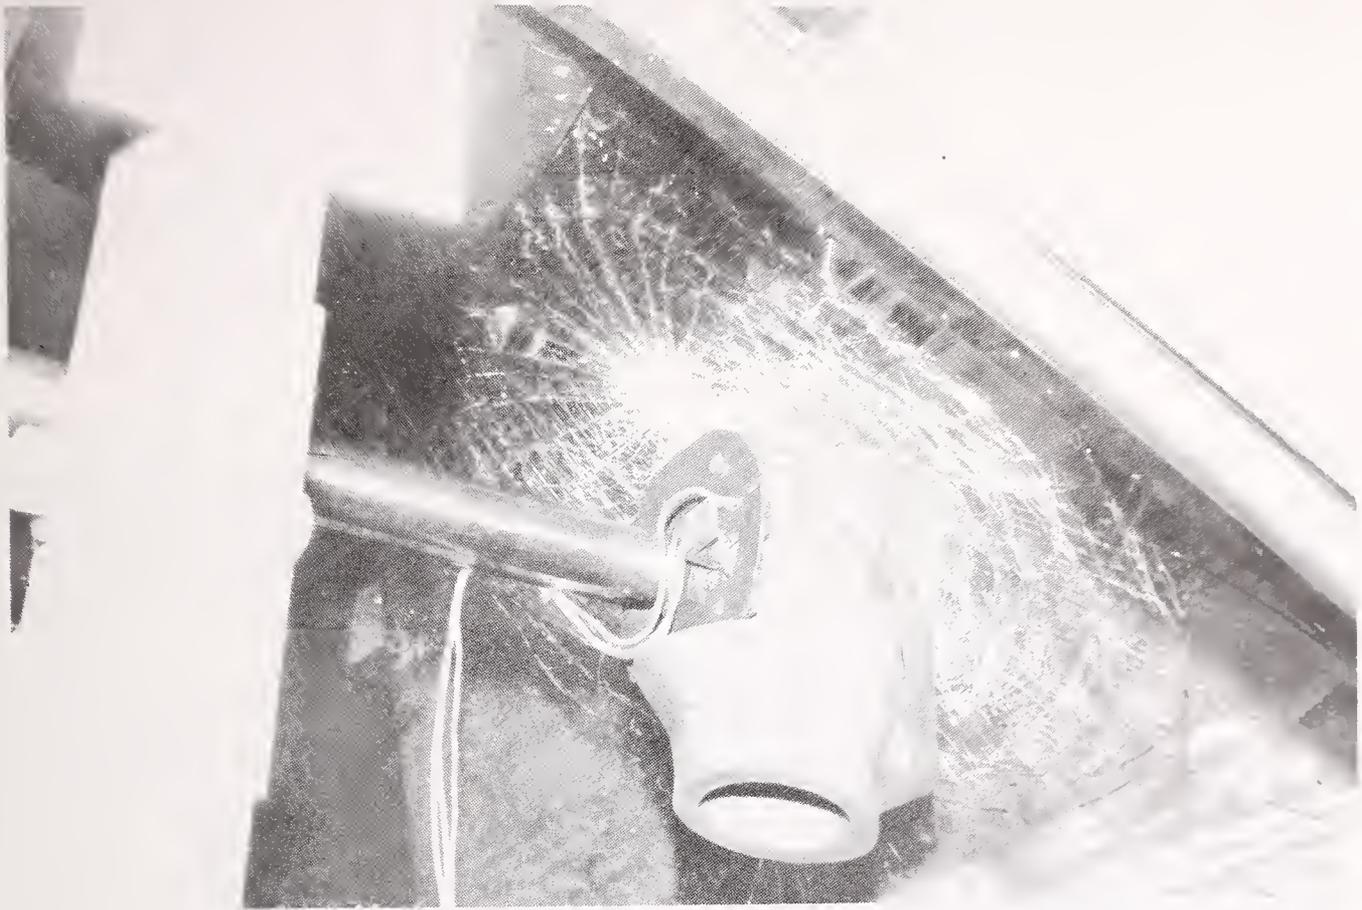
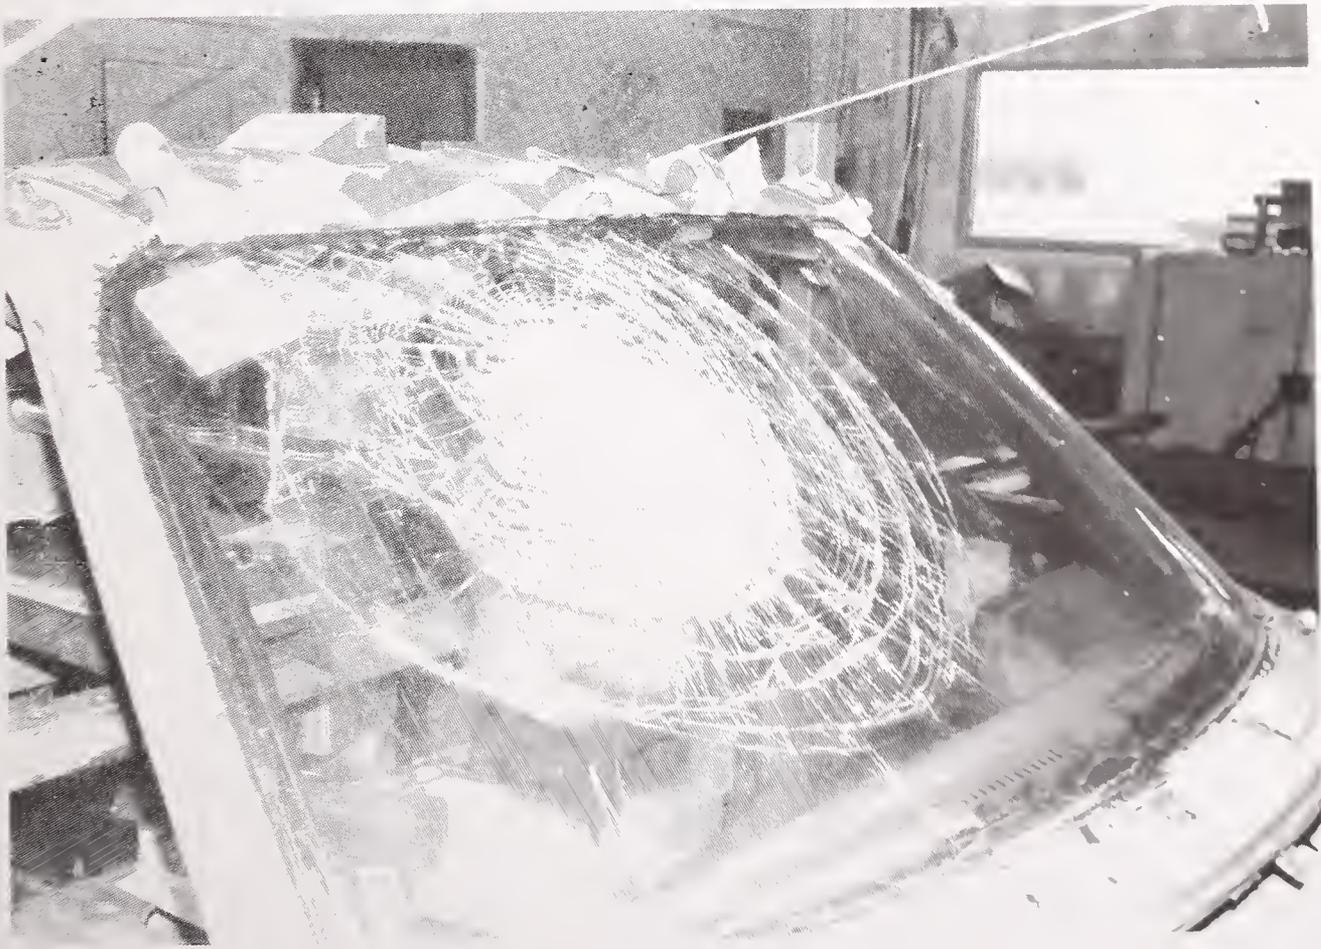
FIGURE 4-30. TYPICAL DYNAMIC HORIZONTAL WINDSHIELD DAMAGE

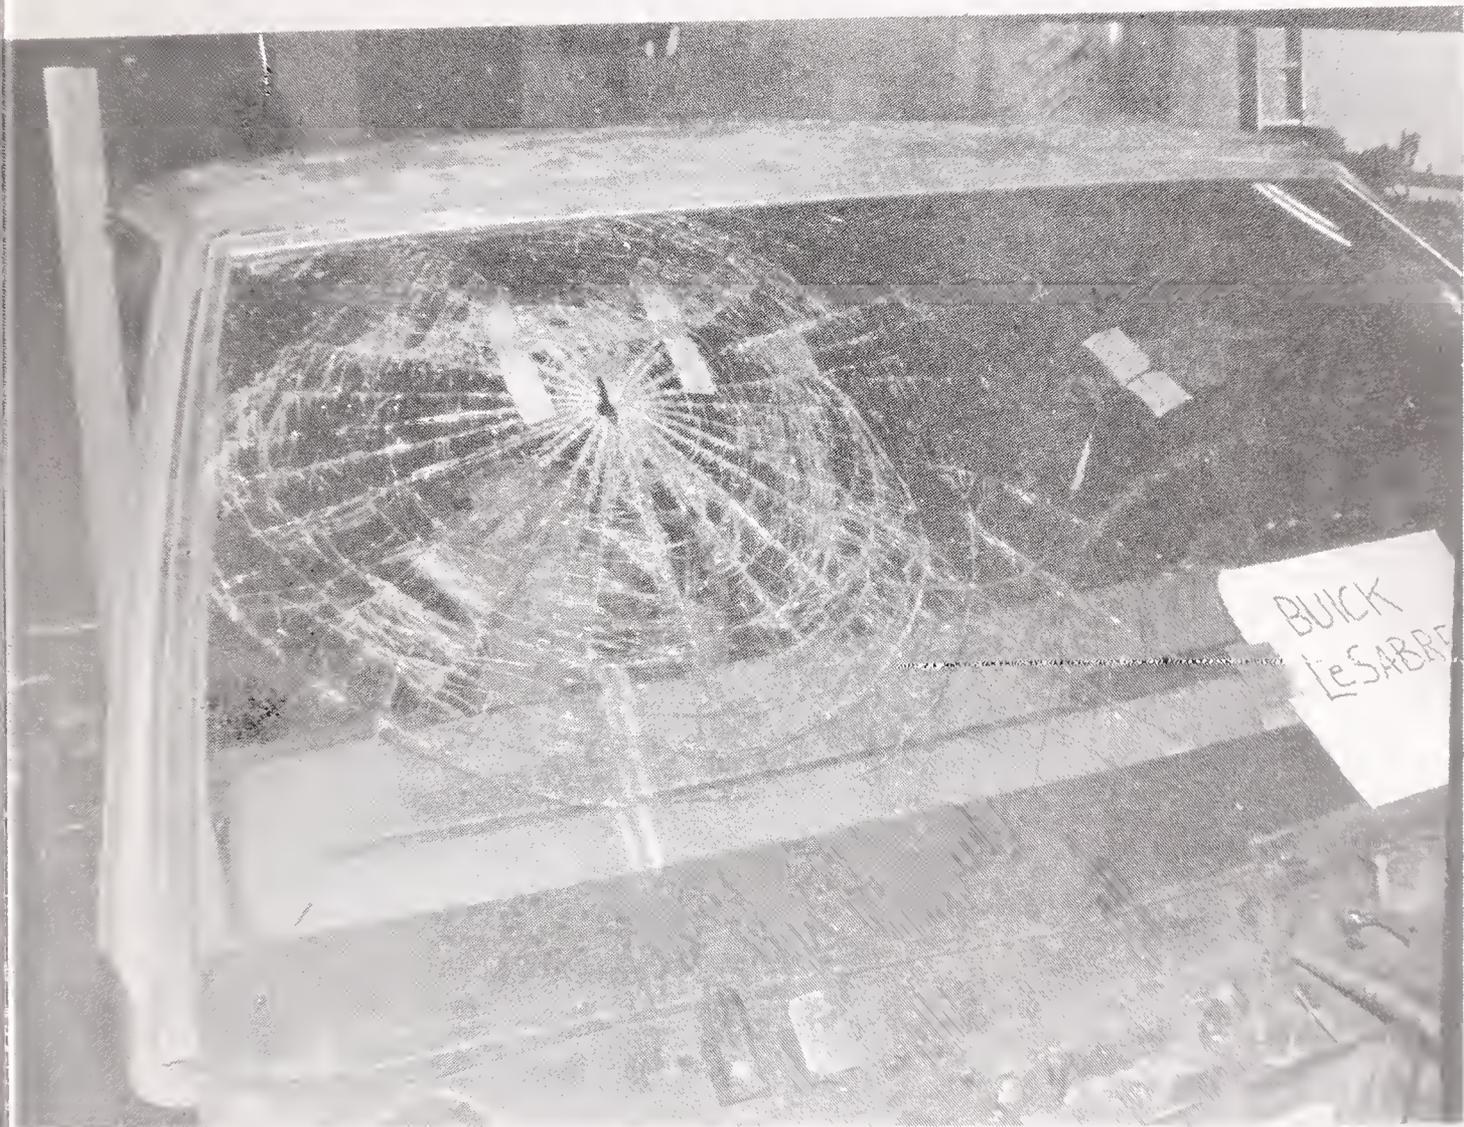
FIGURE 4-32. POST TEST CONDITION OF BUICK LESABRE WINDSHIELD

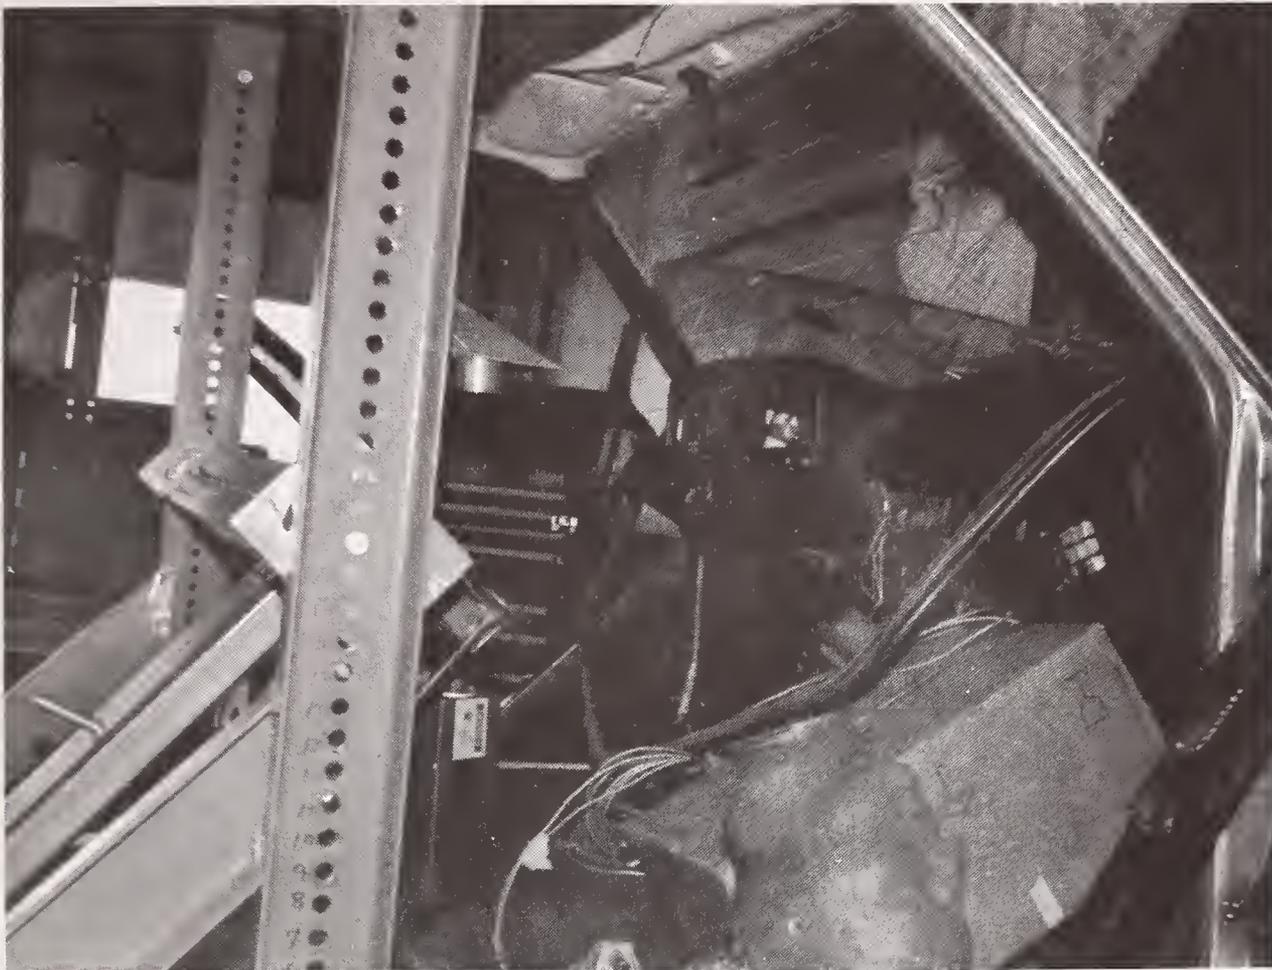
FIGURE 4-33. VOLKSWAGEN RABBIT WINDSHIELD - POST TEST

There were two tests that did not produce the typical windshield damage pattern. The Volkswagen Rabbit windshield is installed with a rubber gasket mount. During this test, the windshield was forced completely out of the gasket. A post test photo is included in Figure 4-33 and the force-deflection data in Figure 4-34. The second test that did not show typical results was the Pontiac LeMans. During this test, a great deal more penetration of the headform through the windshield occurred, as shown in Figure 4-35. The data for this test is in Figure 4-36

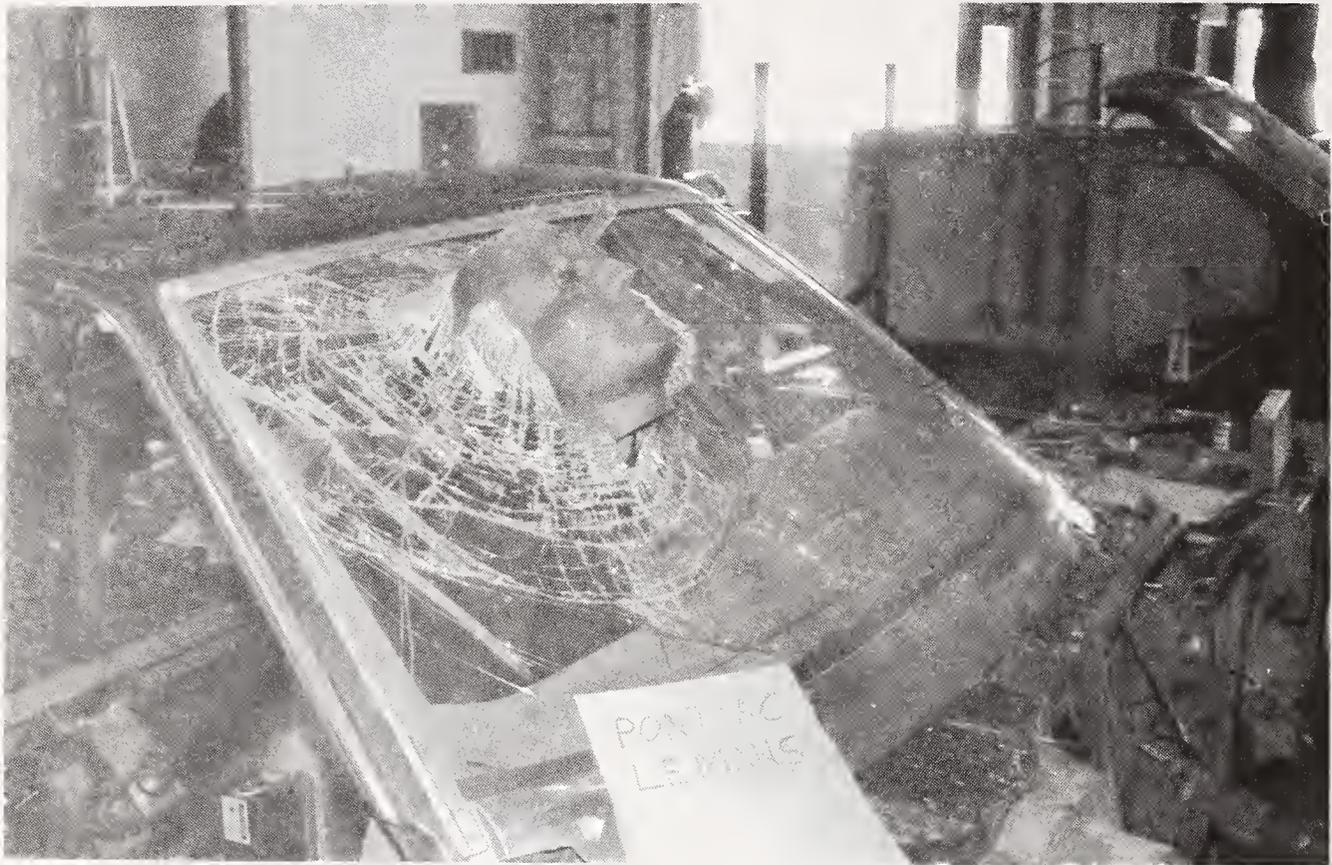
FIGURE 4-35. PONTIAC LEMANS WINDSHIELD - POST TEST
